# Altronic Service Bulletin #521

## Flex Panel Relay Update

### **Affected units: Flex Panels**

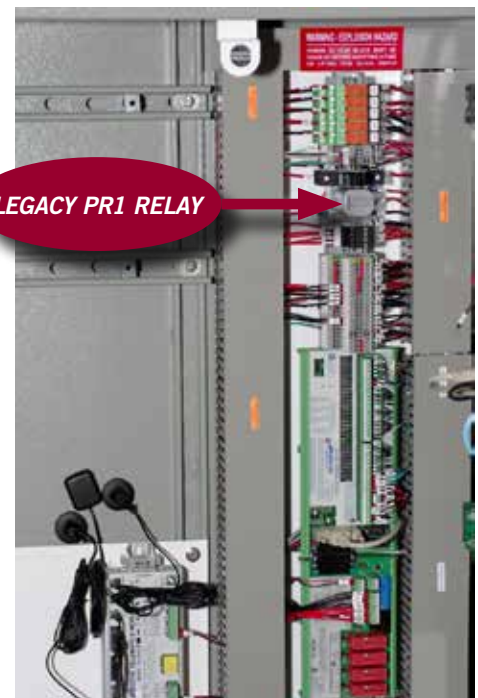
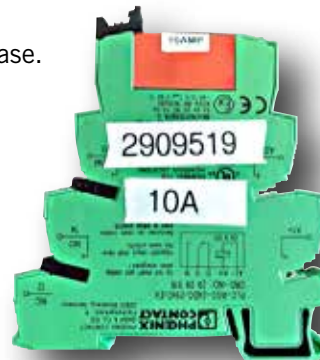
Failure can occur to the PR1 relay. While this is rare, we wanted to make you aware of the problem. The PR1 relay can develop an internal short. This can cause power being controlled by this relay to short into the main power supply circuit of the panel and/or back feed into the digital output channel #5 on the main DE-3000 terminal board.

Power to the panel will not be interrupted by turning off the main power switch on the panel. Back fed voltage to the digital output #5 can result in damage to the DE-3000 primary terminal board.

The new type 10 amp relay, part number 2909519. While this relay looks almost identical to the other 6 amp relays in the panel it is not and therefore cannot be interchanged with the other relays.

Remove the old PR1 relay and disconnect all wire from the relay base.

Install the new replacement relay (2909519).

Attach wires from old relay base to new relay as described below.

Wire #100 to terminal 11 on the new relay.

Wire #107 to terminal 14 on the new relay.

Wire #103 to terminal A1 on the new relay.

Wire #DE5 to terminal A2 on the new relay.
